Name Of Dam: UPPER BEAVER POND DAM
Location: CHESTERFIELD COUNTY
Inventory Number: VA. 04135

PHASE I INSPECTION REPORT

UPPER BEAVER POND DAM
CHESTERFIELD COUNTY
INVENTORY NO. VA 04135

**Deward M. Martin & Associates, Inc.
August 1979**

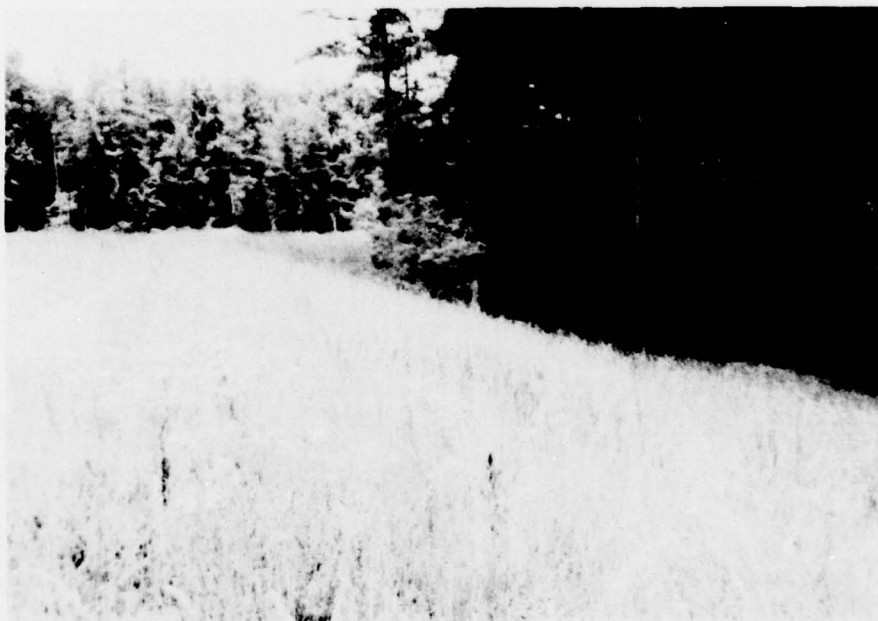
PHOTOGRAPH NO. 2
Left Abutment

*A sewerline passes beneath the dam toward the left abutment. Several holes 1 to 2 feet deep were observed near the sewer crossing.

* 7.3 Remedial Measures and Recommendations: It is recommended that the holes near the sewerline be repaired immediately. Construction records of the sewer installation should be reviewed to allow an evaluation of piping potential. A specialist (Horticulturist) should also evaluate the root characteristics of the existing trees to determine whether the trees should be removed. Although there were no indications of slope stability problems with the dam during normal pool levels, stability analyses of the dam embankment and foundation should be conducted to determine the stability during high pool conditions. Annual inspections of the dam are recommended to determine that the spillways and embankments are in good condition and to anticipate any potential piping problems.

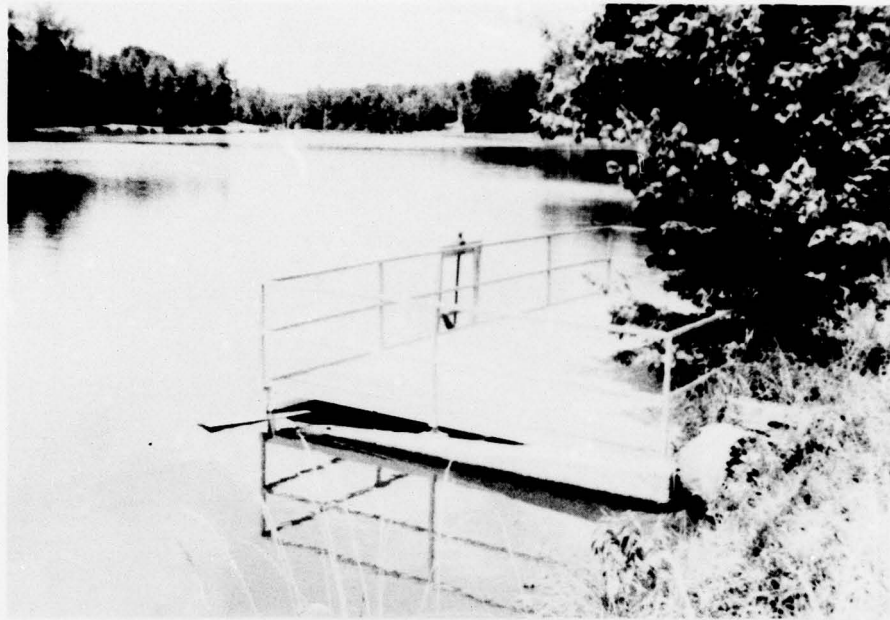
PHOTOGRAPH NO. 3
Principal Spillway

3.1.3 Appurtenant Structures: Observations of the intake structure were made and no deterioration was noted.

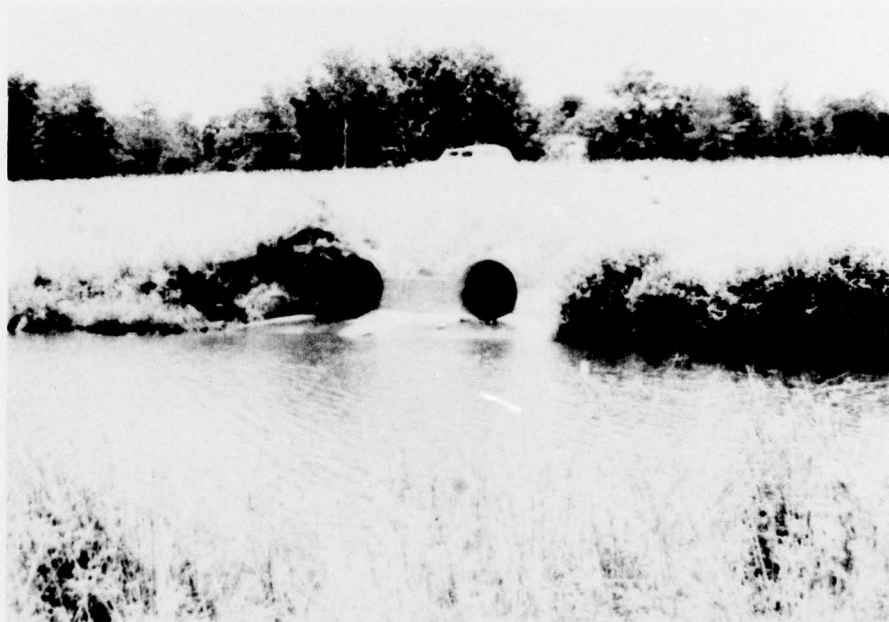
PHOTOGRAPH NO. 4
Outlet of Principal Spillway

3.1.4 Spillway: The two 66-inch diameter concrete discharge pipes which run from the riser structure through the dam appear to be in good condition. These pipes are parallel, approximately 13 feet-6 inches apart, with an invert elevation of 170.0.
